**Flood Control Project Maintenance
Levee Inspections**

Fall 2018 Levee Maintenance Deficiency Summary Report

Sacramento River Basin

**Flood Control Project Maintenance
Levee Inspections****LMA District Cover Sheet****Fall 2018 Levee Inspection Results****Sutter Maintenance Yard Maintenance Area 0013**

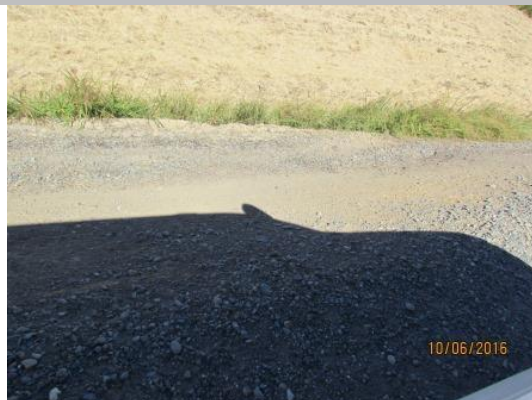
Photo 1 of 1 : FA_2018_MA0013_300_57_20180905_00009.jpg

LM Start	15.58	Rating **	M	Issue No.	57
LM End	15.58	Issue Type +	Ma	Location *	LS
Category	Earthen Levee			GPS Latitude/Longitude	
				Start	End
Item	Slope Stability			39.400380 °	39.400380 °
				-121.808432 °	-121.808432 °
DWR ID	DWR_MA0013_01_f_2016_57				
Comment Code					
S1 : Repair slope instability.					
Inspector Comment

View of slope instability along the landside slope.

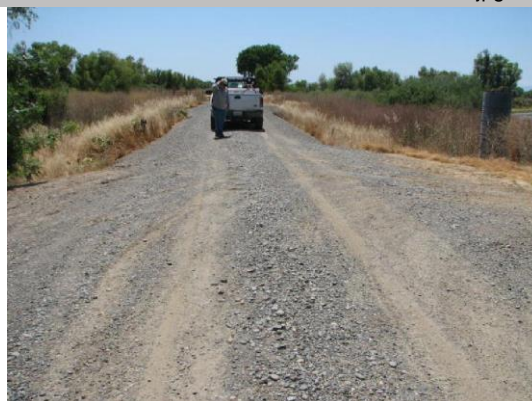
Photo 1 of 3 : UCIP_FA_2018_52243_66989.jpg

Comment Code					
Inspector Comment					
FS_ID:52243 DS_ID:16364 EP_NO: 7521 Repair Type: Non-Urgent Crossing Status: Found UCIP Comments: 6/15/2017 Both pipe ends completely submerged during site visit. Pipe has been selected to be internally cleaned and inspected as part of the DMP project. (DWR Sutter Yard-AFreitag)11/17/2016 Both pipe ends underwater at time of inspection. (DWR Sutter Yard- AFreitag)5/3/2016 Tree near the WS pipe end has been cut down. Stump is still in place. Water was too high to be able to see if the pipe inside was damaged. Minor erosion starting behind the WS headwall.7/13/2015 WS pipe end is heavily vegetated with trees and is making it almost impossible to inspect. Needs to be cleared out. LS appears in good condition.5/22/2014 Same as last inspection.12/3/2013 Same as last inspection.7/15/2013 Slopes have been cleared of vegetation and are in good condition.4/18/2012 Limited inspection on WS and LS slopes/toe due to dense vegetation. Erosion behind headwall on WS toe. Need photos of cleared WS & LS slopes. FIELD_STRUCT_DESC: 30-inch corrugated metal drainage pipe through the levee, 13.6 feet below the crown. Flap gate on the waterside (WS) end. Concrete "U" headwalls on both ends. A 48-inch corrugated metal standpipe located approximately 12 feet from landside (LS) levee toe. (Permit No. 7521, 1972 - Askew Ranch) [Additional Reference(s): DWR Levee Log, 1993. USACE Sacramento O&M Manual 519, June 1962 (HLM 15.95)] FS Date: 6/19/2017 2:02:42 PM

Overview of levee crown at crossing looking downstream.

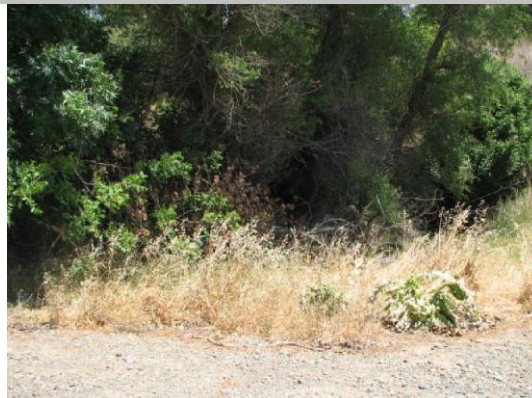
Photo 2 of 3 : UCIP_FA_2018_52243_66987.jpg

View of WS.

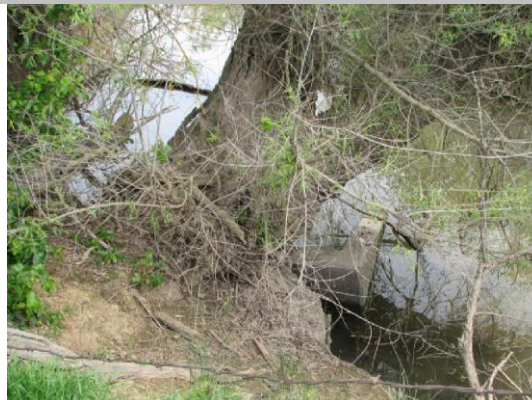
Photo 3 of 3 : UCIP_FA_2018_52243_66986.jpg

Item	DWR UCIP Field Study			39.399051 °	39.399051 °	
				-121.810550 °	-121.810550 °	
DWR ID	16364					
Comment Code						
Inspector Comment						
FS_ID:52243 DS_ID:16364 EP_NO: 7521 Repair Type: Non-Urgent Crossing Status: Found UCIP Comments: 6/15/2017 Both pipe ends completely submerged during site visit. Pipe has been selected to be internally cleaned and inspected as part of the DMP project. (DWR Sutter Yard-AFreitag)11/17/2016 Both pipe ends underwater at time of inspection. (DWR Sutter Yard- AFreitag)5/3/2016 Tree near the WS pipe end has been cut down. Stump is still in place. Water was too high to be able to see if the pipe inside was damaged. Minor erosion starting behind the WS headwall.7/13/2015 WS pipe end is heavily vegetated with trees and is making it almost impossible to inspect. Needs to be cleared out. LS appears in good condition.5/22/2014 Same as last inspection.12/3/2013 Same as last inspection.7/15/2013 Slopes have been cleared of vegetation and are in good condition.4/18/2012 Limited inspection on WS and LS slopes/toe due to dense vegetation. Erosion behind headwall on WS toe. Need photos of cleared WS & LS slopes. FIELD_STRUCT_DESC: 30-inch corrugated metal drainage pipe through the levee, 13.6 feet below the crown. Flap gate on the waterside (WS) end. Concrete "U" headwalls on both ends. A 48-inch corrugated metal standpipe located approximately 12 feet from landside (LS) levee toe. (Permit No. 7521, 1972 - Askew Ranch) [Additional Reference(s): DWR Levee Log, 1993. USACE Sacramento O&M Manual 519, June 1962 (HLM 15.95)] FS Date: 6/19/2017 2:02:42 PM

View of headwall within channel.

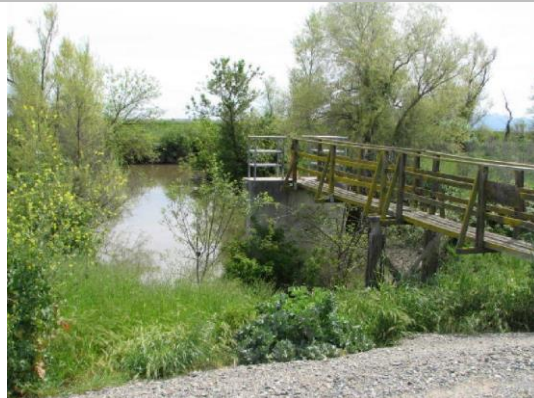
Photo 1 of 3 : UCIP_FA_2018_52244_66993.jpg

FS_ID:52244
DS_ID:16373
EP_NO: 11805B
Repair Type: Non-Urgent
Crossing Status: Found
UCIP Comments: 6/15/2017 Both pipe ends submerged during site visit. LS ditch near pipe end is heavily vegetated and covering the pipe end. There is some erosion happening at the LS levee toe but this is more of a ditch problem and not a problem with the pipe. (DWR Sutter Yard- A Freitag) 11/17/2016 Both pipe ends underwater at time of inspection. (DWR Sutter Yard- A Freitag) 5/03/2016 Crossing was underwater on both sides of levee during this inspection. Looks as if the wooden walkway was the same and no repairs have been made. 7/13/2015 LS inlet still underwater. WS screwgate appears in good condition. Wooden walkway to the screwgate needs repairs. 5/22/2014 Same as last inspection. 12/3/2013 Same as last inspection. 7/15/2013 Same as last inspection. 4/18/2012 LS inlet is not visible-underwater. Limited inspection on WS and LS slope/toe due to dense vegetation. Need photos of cleared WS & LS slopes.

WS view of appurtenances (catwalk, slide gate, and headwall)

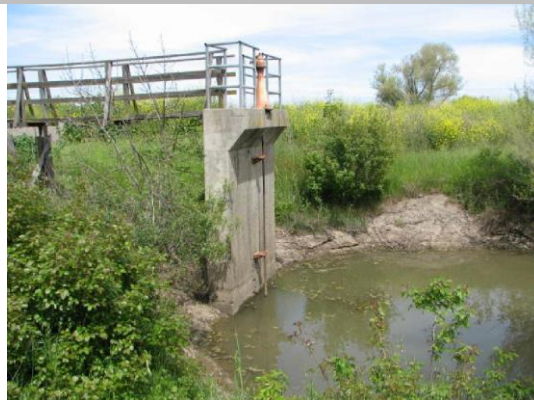
Photo 2 of 3 : UCIP_FA_2018_52244_66995.jpg

WS view of catwalk, slide/screw gate, and headwall

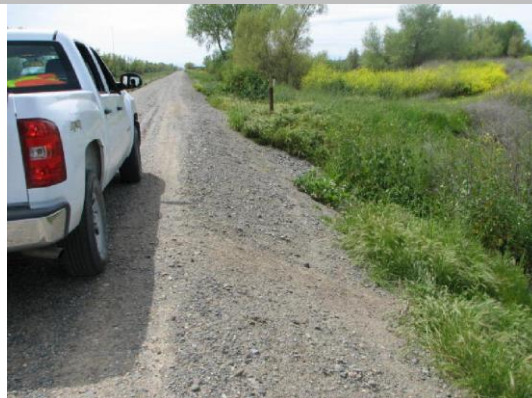
Photo 3 of 3 : UCIP_FA_2018_52244_66996.jpg

Item	DWR UCIP Field Study			39.398615 °	39.398615 °	
				-121.811250 °	-121.811250 °	
DWR ID	16373					
Comment Code						
Inspector Comment						
FS_ID:52244 DS_ID:16373 EP_NO: 11805B Repair Type: Non-Urgent Crossing Status: Found UCIP Comments: 6/15/2017 Both pipe ends submerged during site visit. LS ditch near pipe end is heavily vegetated and covering the pipe end. There is some erosion happening at the LS levee toe but this is more of a ditch problem and not a problem with the pipe. (DWR Sutter Yard- A Freitag)11/17/2016 Both pipe ends underwater at time of inspection. (DWR Sutter Yard- A Freitag)5/03/2016 Crossing was underwater on both sides of levee during this inspection. Looks as if the wooden walkway was the same and no repairs have been made.7/13/2015 LS inlet still underwater. WS screwgate appears in good condition. Wooden walkway to the screwgate needs repairs.5/22/2014 Same as last inspection.12/3/2013 Same as last inspection.7/15/2013 Same as last inspection.4/18/2012 LS inlet is not visible-underwater. Limited inspection on WS and LS slope/toe due to dense vegetation. Need photos of cleared WS & LS slopes. FIELD_STRUCT_DESC: 48-inch reinforced concrete irrigation pipe with six concrete collars through the levee, 14.4 feet below the crown to center of conduit. Slide gate, head-wall and wood walkway on two concrete piers on the waterside (WS) of levee. Revetment on the WS slope. Irrigation ditch on the landside (LS). (Permit No. 11805, 11805B, 1979 - Elna Schohr, Inc.) [Additional Reference(s): DWR Levee Log, 1993] FS Date: 6/19/2017 2:04:34 PM

LS view of shoulder and slope.

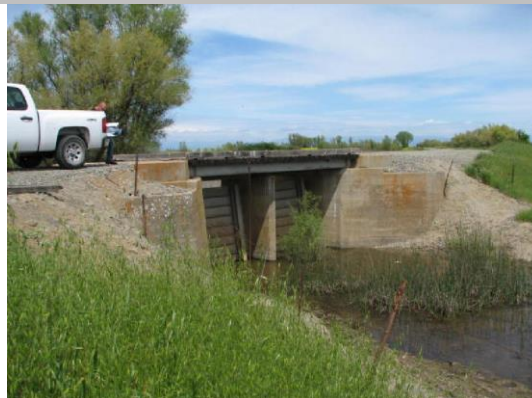
Photo 1 of 3 : UCIP_FA_2018_52245_74500.jpg

Comment Code						
Inspector Comment						
FS_ID:52245 DS_ID:16372 EP_NO: N/A Repair Type: No Action Needed Crossing Status: Found UCIP Comments: 6/15/2017 Crossing appears to be in good condition. Pipe has been selected to be internally cleaned and inspected as part of the DMP project. (DWR Sutter Yard- AFreitag)11/17/2016 Crossing appears to be in good condition. (DWR Sutter Yard- AFreitag)5/03/2016 Crossing appears to be in good condition. 7/13/2015 Crossing appears in good condition. No noticeable issues to report.5/22/2014 Same as last inspection.12/3/2013 Same as last inspection.7/15/2013 Same as last inspection.4/18/2012 The structures are closed with metal stop logs (weir type structure). The stop logs appear to be removable, however; there is a wooden bridge over the structure that would have to be removed in order to raise the stop logs. There is 1-foot of clearance between the bottom of the bridge and the top of the stop logs. FIELD_STRUCT_DESC: Two 10-foot by 10-foot concrete drain openings through the levee at an unknown depth below the crown. Wooden bridge, 10 ton load limit. [Additional Reference(s): DWR Levee Log, 1993. USACE Sacramento O&M Manual 519, June 1962 (HLM 16.43)] FS Date: 6/19/2017 2:09:30 PM

WS view of structure.

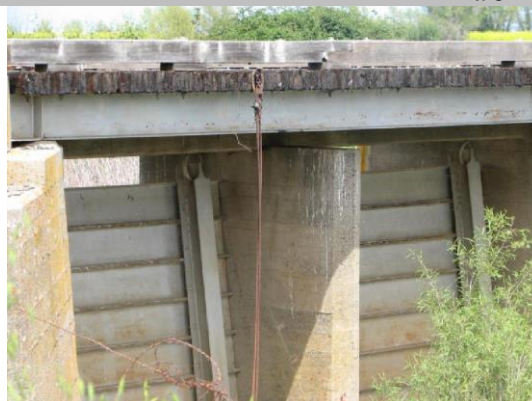
Photo 2 of 3 : UCIP_FA_2018_52245_74503.jpg

View of crossing and panels attached to concrete walls.

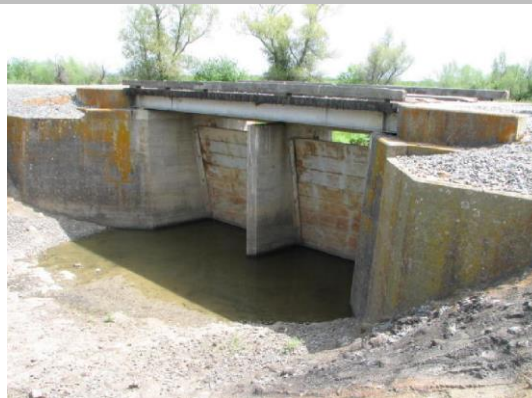
Photo 3 of 3 : UCIP_FA_2018_52245_74501.jpg

Item	DWR UCIP LMA Responsibility			39.394748 °	39.394748 °	
				-121.817360 °	-121.817360 °	
DWR ID	16372					
Comment Code						
Inspector Comment						
FS_ID:52245 DS_ID:16372 EP_NO: N/A Repair Type: No Action Needed Crossing Status: Found UCIP Comments: 6/15/2017 Crossing appears to be in good condition. Pipe has been selected to be internally cleaned and inspected as part of the DMP project. (DWR Sutter Yard- A Freitag)11/17/2016 Crossing appears to be in good condition. (DWR Sutter Yard- A Freitag)5/03/2016 Crossing appears to be in good condition. 7/13/2015 Crossing appears in good condition. No noticeable issues to report.5/22/2014 Same as last inspection.12/3/2013 Same as last inspection.7/15/2013 Same as last inspection.4/18/2012 The structures are closed with metal stop logs (weir type structure). The stop logs appear to be removable, however; there is a wooden bridge over the structure that would have to be removed in order to raise the stop logs. There is 1-foot of clearance between the bottom of the bridge and the top of the stop logs. FIELD_STRUCT_DESC: Two 10-foot by 10-foot concrete drain openings through the levee at an unknown depth below the crown. Wooden bridge, 10 ton load limit. [Additional Reference(s): DWR Levee Log, 1993. USACE Sacramento O&M Manual 519, June 1962 (HLM 16.43)] FS Date: 6/19/2017 2:09:30 PM

LS view of structure

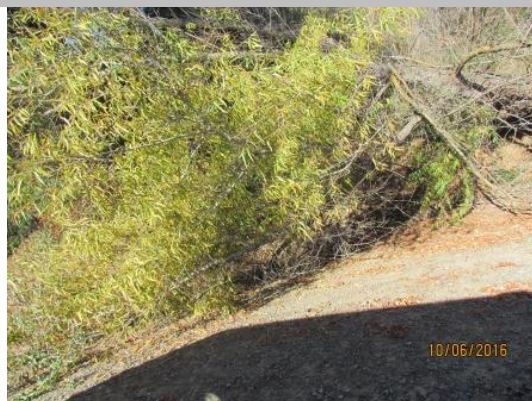
Photo 1 of 1 : FA_2018_MA0013_300_56_20180905_00008.jpg

LM Start	16.52	Rating **	M	Issue No.	56
LM End	16.52	Issue Type +	Ma	Location *	LS
Category	Earthen Levee			GPS Latitude/Longitude	
				Start	End
Item	Trim / Thin Trees			39.391675 °	39.391675 °
				-121.821932 °	-121.821932 °
DWR ID	DWR_MA0013_01_f_2016_56				
Comment Code					
T1 : Trim trees to at least five feet above ground level.					
Inspector Comment

View of dense trees along the landside toe.

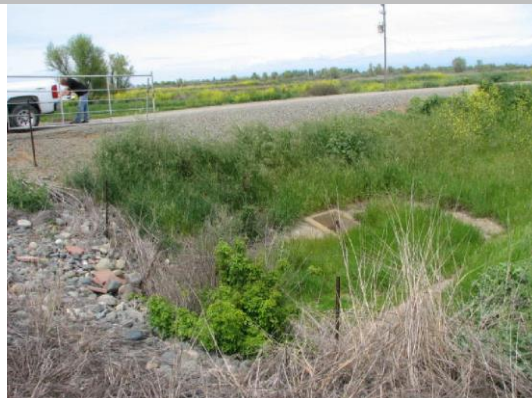
Photo 1 of 3 : UCIP_FA_2018_52249_67017.jpg

FS_ID:52249
DS_ID:16369
EP_NO: N/A
Repair Type: Non-Urgent
Crossing Status: Found
UCIP Comments: 6/15/2017 Flapgate bolted shut. Hinges seem very stiff to operate as gate will not fully close and has about a 1/2" gap near the top. Land owner claims the gate leaks during high water times. Pipe has been selected to be internally cleaned and inspected as part of the DMP project. (DWR Sutter Yard- A/Freitag)11/17/2016 Crossing appears to be in good condition. (DWR Sutter Yard- A/Freitag)5/03/2016 Crossing appears to be in good condition.7/13/2015 WS flap gate is blocked from opening by sediment. Needs to be dug out.5/22/2014 Same as last inspection.12/3/2013 Sediment was dug out from WS flapgate allowing it to open.7/15/2013 Slopes have been sprayed and cleared of vegetation and are in good condition. WS flapgate is blocked from opening by sediment buildup.4/18/2012 Limited inspection on WS and LS slope due to dense vegetation and steep slopes. Need photos of cleared WS & LS slopes.

View of WS slope and toe.

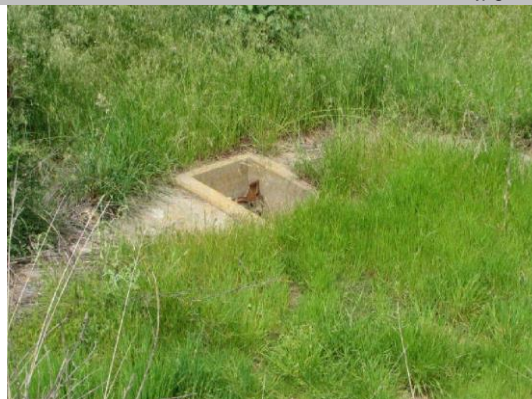
Photo 2 of 3 : UCIP_FA_2018_52249_67019.jpg

View of WS headwall and flap gate.

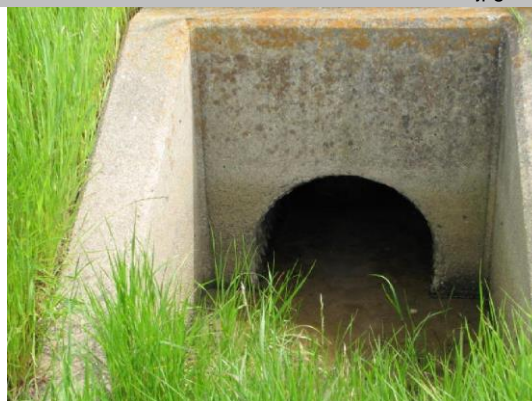
Photo 3 of 3 : UCIP_FA_2018_52249_67018.jpg

Item	DWR UCIP LMA Responsibility			39.385172 °	39.385172 °	
				-121.832060 °	-121.832060 °	
DWR ID	16369					
Comment Code						
Inspector Comment						
FS_ID:52249 DS_ID:16369 EP_NO: N/A Repair Type: Non-Urgent Crossing Status: Found UCIP Comments: 6/15/2017 Flapgate bolted shut. Hinges seem very stiff to operate as gate will not fully close and has about a 1/2" gap near the top. Land owner claims the gate leaks during high water times. Pipe has been selected to be internally cleaned and inspected as part of the DMP project. (DWR Sutter Yard- A Freitag)11/17/2016 Crossing appears to be in good condition. (DWR Sutter Yard- A Freitag)5/03/2016 Crossing appears to be in good condition.7/13/2015 WS flap gate is blocked from opening by sediment. Needs to be dug out.5/22/2014 Same as last inspection.12/3/2013 Sediment was dug out from WS flapgate allowing it to open.7/15/2013 Slopes have been sprayed and cleared of vegetation and are in good condition. WS flapgate is blocked from opening by sediment buildup.4/18/2012 Limited inspection on WS and LS slope due to dense vegetation and steep slopes. Need photos of cleared WS & LS slopes. FIELD_STRUCT_DESC: 24-inch corrugated metal drainage pipe through the levee, 8.1 feet below the crown. Flap gate on the waterside (WS). Concrete "U" headwalls on both WS and landside (LS). [Additional Reference(s): DWR Levee Log, 1993. USACE Sacramento O&M Manual 519, June 1962 (HLM 17.47)] FS Date: 6/19/2017 2:20:18 PM

View of LS headwall.

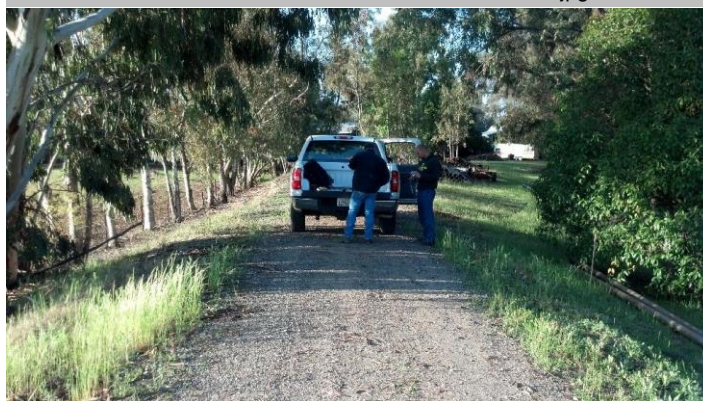
Photo 1 of 3 : UCIP_FA_2018_52111_45640.jpg

FS_ID:52111
DS_ID:16397
EP_NO: N/A
Repair Type: Non-Urgent
Crossing Status: Found
UCIP Comments: 6/5/2017 Crossing appears to be in good condition. (DWR Sutter Yard- AFreitag)11/18/2016 Crossing appears to be in good condition. 4inch pipe still present on LS but it does not affect the function of the crossing. (DWR Sutter Yard- AFreitag)9/27/2016 Crossing has been downgraded from Urgent to Non-Urgent--sleeved pipe does not prevent flap gate from closing on WS. Still need to coordinate with owner to remove sleeved pipe through existing crossing per Title 23. (DWR UCIP - omagana)4/27/2016 Crossing appears to be in good condition. 4 inch pipe is still present in LS opening but does not go all the way through to the WS. (DWR Sutter Yard - afreitag)7/01/2015 Crossing appears in good condition. No noticeable issues to report. (DWR Sutter Yard - afreitag)5/29/2014 Same as last inspection. (DWR Sutter Yard - afreitag)12/9/2013 4in. Pipe was removed and flapgate is closed and ready for high water. (DWR Sutter Yard - afreitag)7/10/2013 Same as last inspection. Urgency rating carry over from last entry. (DWR Sutter Yard - afreitag)4/19/2012 4-6 inch pipe is not part of original crossing--remove pipe. WS-pipe stockpile on WS slope. LS-Overgrown branches limit inspection. This crossing was listed in the USACE Periodic Inspection report listed as Corp's Inspect ID# USACE_CESPK_M13G_2011_p_0009 for WS flap gate not functioning properly as irrigation pipe passes inside crossing. (DWR UCIP - omagana)

Overview looking south on left levee

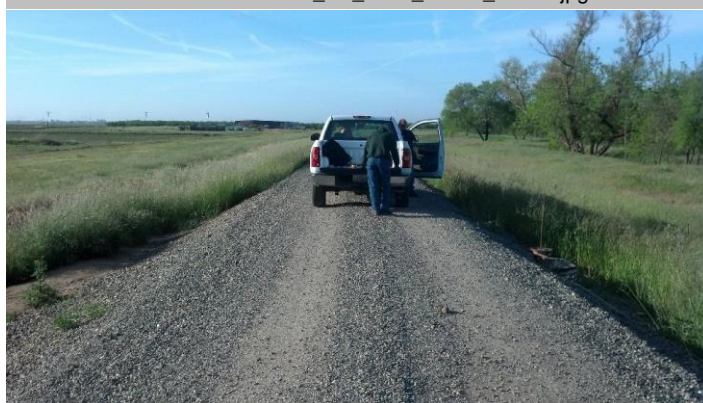
Photo 1 of 3 : UCIP_FA_2018_52112_67047.jpg

UCIP Comments: 6/5/2017 LS ditch at outlet is getting over grown with vegetation. WS near concrete standpipe is overgrown with vegetation. Pipe has been selected to be internally cleaned and inspected as part of the DMP project. (DWR Sutter Yard- A Freitag)11/18/2016 Between the screwgate on the WS shoulder and the LS pipe end the pipe is about 50% full of soil. Crossing is still actively used by landowner for irrigation purposes. (DWR Sutter Yard- A Freitag)4/27/2016 Pipe gets used by the landowner to irrigate his rice fields. It appeared to be in good condition.7/01/2015 LS pipe end is still about 50% full of sediment.5/29/2014 Same as last inspection.12/9/2013 Same as last inspection.7/10/2013 LS and WS slopes have been cleared of vegetation and are in good condition. LS pipe end is half full of sediment. Sediment inside of WS standpipe may hinder slide gate from fully closing. Standpipe cover is still broken.4/19/2012 Need to fix the top of slide gate cover. The wooden cap on standpipe is broken. Limited evaluation of crossing due to dense vegetation on LS slope. Need photos of cleared slopes during fall inspection.

Overview looking south

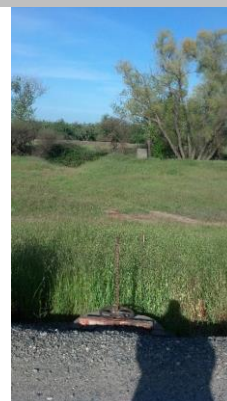
Photo 2 of 3 : UCIP_FA_2018_52112_67048.jpg

Comment Code						
Inspector Comment						
FS_ID:52112 DS_ID:16398 EP_NO: N/A Repair Type: Non-Urgent Crossing Status: Found UCIP Comments: 6/5/2017 LS ditch at outlet is getting over grown with vegetation. WS near concrete standpipe is overgrown with vegetation. Pipe has been selected to be internally cleaned and inspected as part of the DMP project. (DWR Sutter Yard- A Freitag)11/18/2016 Between the screwgate on the WS shoulder and the LS pipe end the pipe is about 50% full of soil. Crossing is still actively used by landowner for irrigation purposes. (DWR Sutter Yard- A Freitag)4/27/2016 Pipe gets used by the landowner to irrigate his rice fields. It appeared to be in good condition.7/01/2015 LS pipe end is still about 50% full of sediment.5/29/2014 Same as last inspection.12/9/2013 Same as last inspection.7/10/2013 LS and WS slopes have been cleared of vegetation and are in good condition. LS pipe end is half full of sediment. Sediment inside of WS standpipe may hinder slide gate from fully closing. Standpipe cover is still broken.4/19/2012 Need to fix the top of slide gate cover. The wooden cap on standpipe is broken. Limited evaluation of crossing due to dense vegetation on LS slope. Need photos of cleared slopes during fall inspection. FIELD_STRUCT_DESC: 24-inch corrugated metal drainage pipe through the levee, 10.6 feet below the crown. Slide gate in corrugated metal pipe (CMP) riser on the waterside (WS) slope. Concrete "U" headwall on the landside (LS). 36-inch concrete standpipe in the channel with two wooden piles to deflect debris. [Additional Reference(s): DWR Levee Log, 1993. USACE Sacramento O&M Manual 519, June 1962 (HLM 0.57)] FS Date: 6/7/2017 12:03:30 PM

View of WS slope and toe.

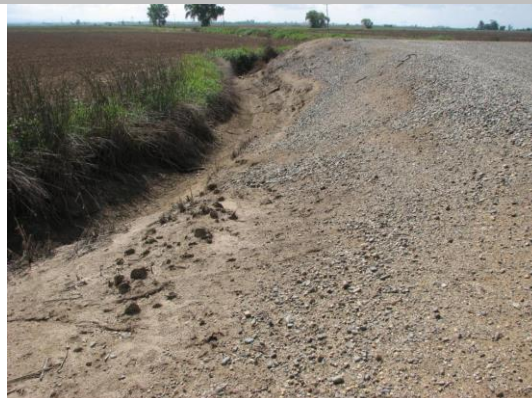
Photo 1 of 1 : FA_2018_MA0013_301_56_20180905_00013.jpg

LM Start	1.60	Rating **	U	Issue No.	56
LM End	1.63	Issue Type +	En	Location *	LS
Category	Earthen Levee			GPS Latitude/Longitude	
				Start	End
Item	Encroachments			39.552195°	39.551731°
				-121.704786°	-121.704721°
DWR ID	DWR_MA0013_02_s_2016_56				
Comment Code					
DT : Ditch					
Inspector Comment

View of the agricultural ditch along the landside toe.

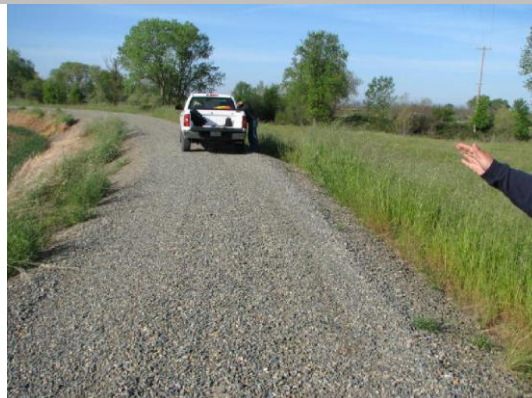
Photo 1 of 3 : UCIP_FA_2018_52114_67059.jpg

FS_ID:52114
DS_ID:16399
EP_NO: N/A
Repair Type: Non-Urgent
Crossing Status: Found
UCIP Comments: 6/5/2017 LS slide gate stem is bent and the gate appears as if it will not open. LS inlet is becoming heavily vegetated next to rice field. WS flap gate is blocked shut by sediment. Pipe has been selected to be internally cleaned and inspected as part of the DMP project. (DWR Sutter Yard- A Freitag)11/18/2016 LS screw gate still bent and in-operable. (DWR Sutter Yard- A Freitag)4/27/2016 LS screw gate is still bent. Rest of crossing appeared in good condition.7/01/2015 LS screw gate frame is still twisted and hindering the gate from opening.5/29/2014 Same as last inspection.12/9/2013 Same as last inspection.7/10/2013 WS slope is cleared of vegetation and is in good condition. LS screw gate frame is twisted and is preventing the gate from opening.4/19/2012 Limited inspection dense vegetation on WS. Need photos of clear WS slope & toe. Ditch present in channel? This crossing was listed in the USACE Periodic Inspection report as Corp's Inspect ID# USACE_CESPK_M13G_2011_p_0108 for WS flap gate filled with soil and LS gate not functioning because of overgrown vegetation. FIELD_STRUCT_DESC: 24-inch corrugated metal drainage pipe through the levee, 7.9 feet below the crown. Concrete "U" headwalls on both waterside (WS) and landside (LS) ends. Flap gate on the WS end. Slide gate at the LS toe in headwall. In 1962, permit number 3953 was issued for existing pump structure, intake box, ditch and power pole. In 1963, the pump and intake box were removed. (Permit No. 3953, 1960 - Dr. John O. Gibbs, DBA Empire Land Company) [Additional Reference(s): DWR Levee Log, 1993. USACE Sacramento O&M Manual 519, June 1962 (HLM 1.70)]

Overview of crossing

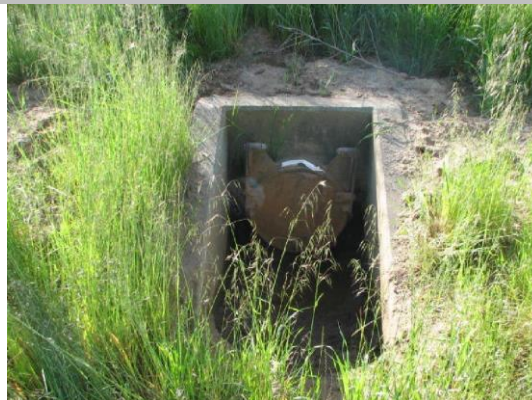
Photo 2 of 3 : UCIP_FA_2018_52114_67058.jpg

FS_ID:52114
DS_ID:16399
EP_NO: N/A
Repair Type: Non-Urgent
Crossing Status: Found
UCIP Comments: 6/5/2017 LS slide gate stem is bent and the gate appears as if it will not open. LS inlet is becoming heavily vegetated next to rice field. WS flap gate is blocked shut by sediment. Pipe has been selected to be internally cleaned and inspected as part of the DMP project. (DWR Sutter Yard- A Freitag)11/18/2016 LS screw gate still bent and in-operable. (DWR Sutter Yard- A Freitag)4/27/2016 LS screw gate is still bent. Rest of crossing appeared in good condition.7/01/2015 LS screw gate frame is still twisted and hindering the gate from opening.5/29/2014 Same as last inspection.12/9/2013 Same as last inspection.7/10/2013 WS slope is cleared of vegetation and is in good condition. LS screw gate frame is twisted and is preventing the gate from opening.4/19/2012 Limited inspection dense vegetation on WS. Need photos of clear WS slope & toe. Ditch present in channel? This crossing was listed in the USACE Periodic Inspection report as Corp's Inspect ID# USACE_CESPK_M13G_2011_p_0108 for WS flap gate filled with soil and LS gate not functioning because of overgrown vegetation. FIELD_STRUCT_DESC: 24-inch corrugated metal drainage pipe through the levee, 7.9 feet below the crown. Concrete "U" headwalls on both waterside (WS) and landside (LS) ends. Flap gate on the WS end. Slide gate at the LS toe in headwall. In 1962, permit number 3953 was issued for existing pump structure, intake box, ditch and power pole. In 1963, the pump and intake box were removed. (Permit No. 3953, 1960 - Dr. John O. Gibbs, DBA Empire Land Company) [Additional Reference(s): DWR Levee Log, 1993. USACE Sacramento O&M Manual 519, June 1962 (HLM 1.70)]

View of flap gate on WS.

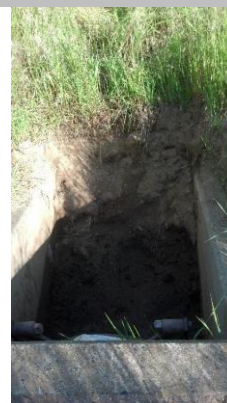
Photo 3 of 3 : UCIP_FA_2018_52114_67057.jpg

UCIP Comments: 6/5/2017 LS slide gate stem is bent and the gate appears as if it will not open. LS inlet is becoming heavily vegetated next to rice field. WS flap gate is blocked shut by sediment. Pipe has been selected to be internally cleaned and inspected as part of the DMP project. (DWR Sutter Yard- A Freitag)11/18/2016 LS screw gate still bent and in-operable. (DWR Sutter Yard- A Freitag)4/27/2016 LS screw gate is still bent. Rest of crossing appeared in good condition.7/01/2015 LS screw gate frame is still twisted and hindering the gate from opening.5/29/2014 Same as last inspection.12/9/2013 Same as last inspection.7/10/2013 WS slope is cleared of vegetation and is in good condition. LS screw gate frame is twisted and is preventing the gate from opening.4/19/2012 Limited inspection dense vegetation on WS. Need photos of clear WS slope & toe. Ditch present in channel? This crossing was listed in the USACE Periodic Inspection report as Corp's Inspect ID# USACE_CESPK_M13G_2011_p_0108 for WS flap gate filled with soil and LS gate not functioning because of overgrown vegetation. FIELD_STRUCT_DESC: 24-inch corrugated metal drainage pipe through the levee, 7.9 feet below the crown. Concrete "U" headwalls on both waterside (WS) and landside (LS) ends. Flap gate on the WS end. Slide gate at the LS toe in headwall. In 1962, permit number 3953 was issued for existing pump structure, intake box, ditch and power pole. In 1963, the pump and intake box were removed. (Permit No. 3953, 1960 - Dr. John O. Gibbs, DBA Empire Land Company) [Additional Reference(s): DWR Levee Log, 1993. USACE Sacramento O&M Manual 519, June 1962 (HLM 1.70)]

View of WS toe.

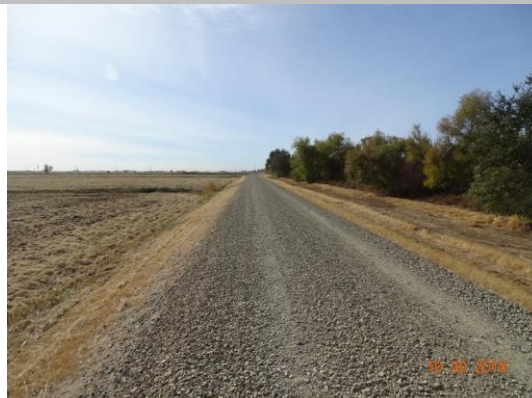
Photo 1 of 1 : FA_2018_MA0013_301_61_20181102_00135.jpg

LM Start	2.39	Rating **	A	Issue No.	61
LM End	2.39	Issue Type +	Ma	Location *	LS
Category	Earthen Levee			GPS Latitude/Longitude	
				Start	End
Item	Vegetation			39.541153 °	39.541153 °
				-121.706070 °	-121.706070 °
DWR ID	DWR_MA0013_02_f_2018_61				
Comment Code					
V1 : Control annual grass and weeds on the levee slopes and easements.					
Inspector Comment					
The vegetation was mowed on both slopes.

View of the mowed vegetation on both slopes.

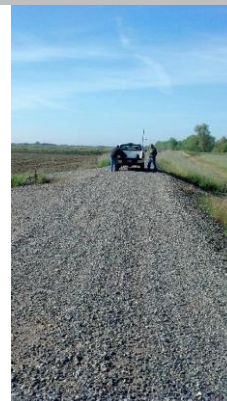
Photo 1 of 3 : UCIP_FA_2018_52115_67063.jpg

Comment Code					
Inspector Comment					
FS_ID:52115 DS_ID:16400 EP_NO: N/A Repair Type: No Action Needed Crossing Status: Found UCIP Comments: 6/5/2017 LS inlet was underwater. WS flapgate blocked shut by sediment. Pipe has been selected to be internally cleaned and inspected as part of the DMP project. (DWR Sutter Yard-AFreitag)11/18/2016 Sediment dug out from in front of flap gate. Gate can now function properly. (DWR Sutter Yard-AFreitag)4/27/2016 WS flapgate still blocked from opening by sediment buildup.7/01/2015 New screwgate installed on the LS. WS flapgate is still blocked from opening by sediment.5/29/2014 Same as last inspection.12/9/2013 Same as last inspection.7/10/2013 Sediment is built up against WS flap gate not allowing it to open. Handle for LS slide gate is still missing.4/19/2012 Handle missing on slide gate. FIELD_STRUCT_DESC: 1 of 2: 36-inch corrugated metal drainage pipe through the levee, 9.7 feet below the crown. Concrete "U" headwalls located on the waterside (WS) and landside (LS) ends. Flap gate on the WS end. Slide gate on the LS end. [Additional Reference(s): DWR Levee Log, 1993. USACE Sacramento O&M Manual 519, June 1962 (HLM 2.54)] FS Date: 6/7/2017 12:18:14 PM

Overview of levee crown looking south

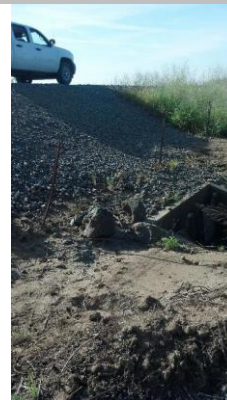
Photo 2 of 3 : UCIP_FA_2018_52115_67068.jpg

Item	DWR UCIP LMA Responsibility			39.539195°	39.539195°	
				-121.706070°	-121.706070°	
DWR ID	16400					
Comment Code						
Inspector Comment						
FS_ID:52115						
DS_ID:16400						
EP_NO: N/A						
Repair Type: No Action Needed						
Crossing Status: Found						
UCIP Comments: 6/5/2017 LS inlet was underwater. WS flapgate blocked shut by sediment. Pipe has been selected to be internally cleaned and inspected as part of the DMP project. (DWR Sutter Yard-AFreitag)11/18/2016 Sediment dug out from in front of flap gate. Gate can now function properly. (DWR Sutter Yard-AFreitag)4/27/2016 WS flapgate still blocked from opening by sediment buildup.7/01/2015 New screwgate installed on the LS. WS flapgate is still blocked from opening by sediment.5/29/2014 Same as last inspection.12/9/2013 Same as last inspection.7/10/2013 Sediment is built up against WS flap gate not allowing it to open. Handle for LS slide gate is still missing.4/19/2012 Handle missing on slide gate.

View of WS slope.

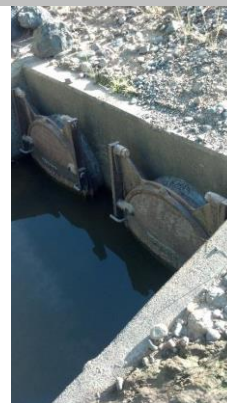
Photo 3 of 3 : UCIP_FA_2018_52115_67064.jpg

Headwall and flap gates (2) located on WS

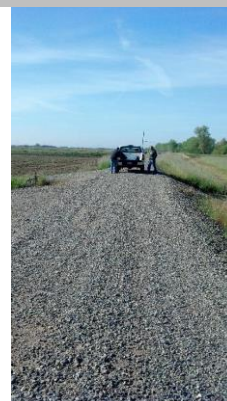
Photo 1 of 3 : UCIP_FA_2018_52116_67075.jpg

Comment Code					
Inspector Comment					
FS_ID:52116					
DS_ID:17169					
EP_NO: N/A					
Repair Type: No Action Needed					
Crossing Status: Found					
UCIP Comments: 6/5/2017 LS inlet was underwater. WS appears to be in good condition. Pipe has been selected to be internally cleaned and inspected as part of the DMP project. (DWR Sutter Yard- A/Freitag)11/18/2016 Crossing appears to be in good condition. (DWR Sutter Yard- A/Freitag)4/27/2016 Crossing appears to be in good condition.7/01/2015 New screwgate installed on the LS. WS appears to be in good condition.5/29/2014 Same as last inspection.12/9/2013 Same as last inspection.7/10/2013 Same as last inspection.					
FIELD_STRUCT_DESC: 2 of 2: 36-inch corrugated metal drainage pipe through the levee, 9.7 feet below the crown. Concrete "U" headwalls on both the waterside (WS) and landside (LS) ends. Flap gate on the waterside (WS) end. Slide gate on the landside (LS) end. [Additional Reference(s): DWR Levee Log, 1993. USACE Sacramento O&M Manual 519, June 1962 (HLM 2.54)]

Overview at levee crown looking south

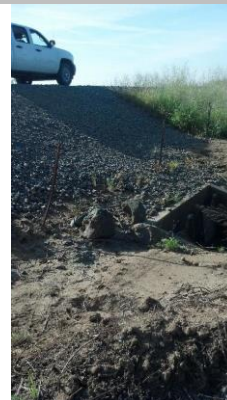
Photo 2 of 3 : UCIP_FA_2018_52116_67074.jpg

View of WS slope.

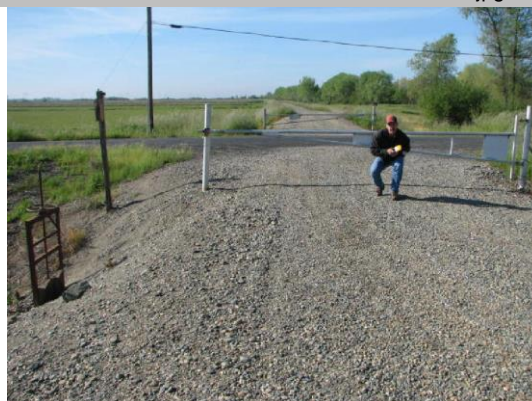
Photo 1 of 3 : UCIP_FA_2018_52117_67077.jpg

FIELD_STRUCT_DESC: 36-inch corrugated metal drainage pipe through the levee, 8.8 feet below the crown. Concrete "U" headwalls located on both the waterside (WS) and landside (LS) ends. Flap gate on the WS end. Slide gate on the LS end. Structure used to drain water from Nelson Shippe Road. [Additional Reference(s): DWR Levee Log, 1993. USACE Sacramento O&M Manual 519, June 1962 (HLM 2.63)]						
FS Date: 6/7/2017 12:45:23 PM

Overview looking south from left levee

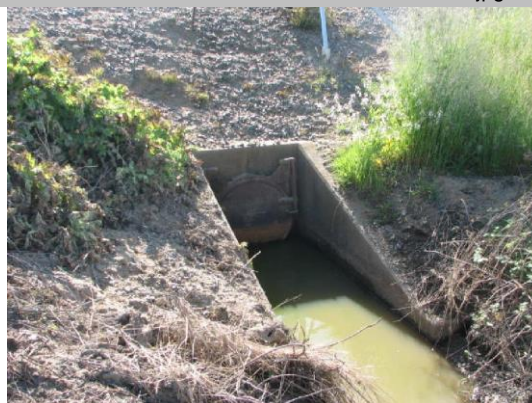
Photo 2 of 3 : UCIP_FA_2018_52117_67076.jpg

Comment Code						
Inspector Comment						
FS_ID:52117 DS_ID:16402 EP_NO: N/A Repair Type: Non-Urgent Crossing Status: Found UCIP Comments: 6/5/2017 Sediment blocking LS slide gate from closing fully. Pipe has been selected to be internally cleaned and inspected as part of the DMP project. (DWR Sutter Yard-AFreitag)11/18/2016 Sediment still blocking screw gate from fully closing. (DWR Sutter Yard- AFreitag)4/27/2016 LS slide gate is full of sediment and needs to be dug out so gate can close fully.7/01/2015 LS screwgate is still silted in and unable to be screwed down all the way. Needs to be cleaned out.5/29/2014 Same as last inspection.12/9/2013 WS flapgate was closed but LS slidegate is heavily vegetated and blocked from closing by sediment.7/10/2013 Same as last inspection.4/19/2012 Minor sediment built up on LS, remove sediment. Need photo of LS slide gate without sediment build up. This crossing was listed in the USACE Periodic Inspection report as Corp's inspect ID# USACE_CESPK_M13G_2011_p_0148 for LS gate obstructed by vegetation and WS flap gate is not functioning (propped open). FIELD_STRUCT_DESC: 36-inch corrugated metal drainage pipe through the levee, 8.8 feet below the crown. Concrete "U" headwalls located on both the waterside (WS) and landside (LS) ends. Flap gate on the WS end. Slide gate on the LS end. Structure used to drain water from Nelson Shippe Road. [Additional Reference(s): DWR Levee Log, 1993. USACE Sacramento O&M Manual 519, June 1962 (HLM 2.63)] FS Date: 6/7/2017 12:45:23 PM

Headwall and flap gate located on WS.

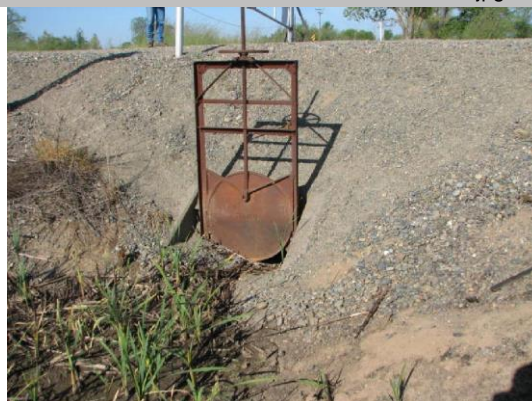
Photo 3 of 3 : UCIP_FA_2018_52117_67078.jpg

FS_ID:52117
DS_ID:16402
EP_NO: N/A
Repair Type: Non-Urgent
Crossing Status: Found
UCIP Comments: 6/5/2017 Sediment blocking LS slide gate from closing fully. Pipe has been selected to be internally cleaned and inspected as part of the DMP project. (DWR Sutter Yard- A Freitag)11/18/2016 Sediment still blocking screw gate from fully closing. (DWR Sutter Yard- A Freitag)4/27/2016 LS slide gate is full of sediment and needs to be dug out so gate can close fully.7/01/2015 LS screwgate is still silted in and unable to be screwed down all the way. Needs to be cleaned out.5/29/2014 Same as last inspection.12/9/2013 WS flapgate was closed but LS slidegate is heavily vegetated and blocked from closing by sediment.7/10/2013 Same as last inspection.4/19/2012 Minor sediment built up on LS, remove sediment. Need photo of LS slide gate without sediment build up. This crossing was listed in the USACE Periodic Inspection report as Corp's inspect ID# USACE_CESPK_M13G_2011_p_0148 for LS gate obstructed by vegetation and WS flap gate is not functioning (propped open).

Headwall and screw gate located on LS.

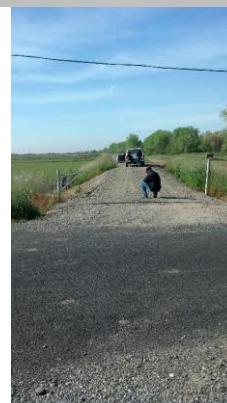
Photo 1 of 3 : UCIP_FA_2018_52119_67087.jpg

Comment Code						
Inspector Comment						
FS_ID:52119 DS_ID:16403 EP_NO: N/A Repair Type: Non-Urgent Crossing Status: Found UCIP Comments: 6/5/2017 Crossing appears to be in good condition. Pipe has been selected to be internally cleaned and inspected as part of the DMP project. (DWR Sutter Yard- AFreitag)11/18/2016 Crossing appears to be in good condition. (DWR Sutter Yard- AFreitag)4/27/2016 Crossing appears to be in good condition.7/01/2015 WS flap gate is partially blocked by sediment and needs to be cleaned.5/29/2014 Same as last inspection.12/9/2013 Same as last inspection.7/10/2013 LS and WS slopes have been cleared of vegetation and are in good condition.4/19/2012 Burrowing holes located above WS headwall. Limited inspection on WS and LS slopes due to dense vegetation. Need photos of cleared WS & LS slopes. FIELD_STRUCT_DESC: 36-inch corrugated metal drainage pipe through the levee, 8.7 feet below the crown. Concrete "U" headwalls located on the waterside (WS) and landside (LS) ends. Flap gate on the WS end. Slide gate on the LS end. [Additional Reference(s): DWR Levee Log, 1993. USACE Sacramento O&M Manual 519, June 1962 (HLM 2.65)] FS Date: 6/7/2017 12:48:30 PM

Overview at levee crown looking south

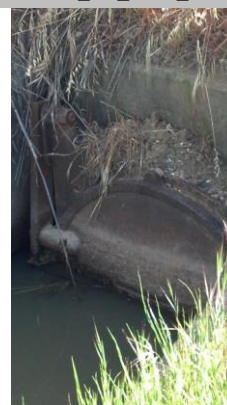
Photo 2 of 3 : UCIP_FA_2018_52119_67084.jpg

Headwall and flap gate located on WS

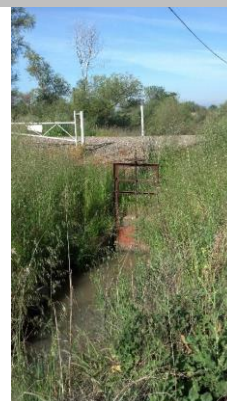
Photo 3 of 3 : UCIP_FA_2018_52119_67086.jpg

Comment Code						
Inspector Comment						
FS_ID:52119 DS_ID:16403 EP_NO: N/A Repair Type: Non-Urgent Crossing Status: Found UCIP Comments: 6/5/2017 Crossing appears to be in good condition. Pipe has been selected to be internally cleaned and inspected as part of the DMP project. (DWR Sutter Yard- AFreitag)11/18/2016 Crossing appears to be in good condition. (DWR Sutter Yard- AFreitag)4/27/2016 Crossing appears to be in good condition.7/01/2015 WS flap gate is partially blocked by sediment and needs to be cleaned.5/29/2014 Same as last inspection.12/9/2013 Same as last inspection.7/10/2013 LS and WS slopes have been cleared of vegetation and are in good condition.4/19/2012 Burrowing holes located above WS headwall. Limited inspection on WS and LS slopes due to dense vegetation. Need photos of cleared WS & LS slopes. FIELD_STRUCT_DESC: 36-inch corrugated metal drainage pipe through the levee, 8.7 feet below the crown. Concrete "U" headwalls located on the waterside (WS) and landside (LS) ends. Flap gate on the WS end. Slide gate on the LS end. [Additional Reference(s): DWR Levee Log, 1993. USACE Sacramento O&M Manual 519, June 1962 (HLM 2.65)] FS Date: 6/7/2017 12:48:30 PM

Headwall and screw gate located on the LS

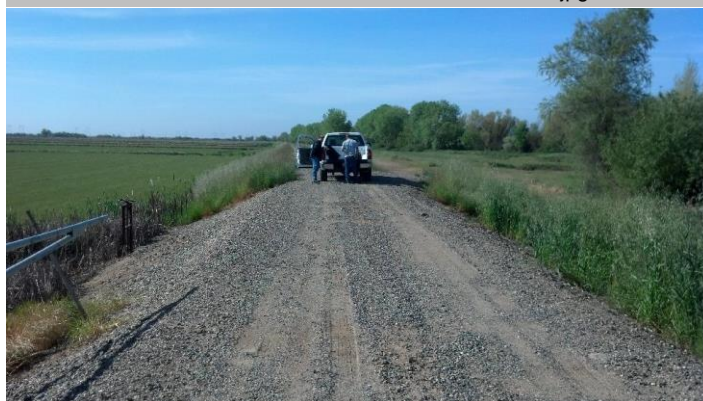
Photo 1 of 3 : UCIP_FA_2018_52120_67090.jpg

Comment Code					
Inspector Comment					
FS_ID:52120 DS_ID:16415 EP_NO: N/A Repair Type: Non-Urgent Crossing Status: Found UCIP Comments: 6/5/2017 Both gates partially submerged during site visit. Appears to be in good condition. Pipe has been selected to be internally cleaned and inspected as part of the DMP project. (DWR Sutter Yard- A Freitag)11/18/2016 LS screw gate closed but partially buried. WS flapgate was half submerged for inspection. (DWR Sutter Yard- A Freitag)4/27/2016 Both gates were underwater for inspection.7/01/2015 WS flap gate is partially held open by sediment and needs to be dug out to allow it to fully close.5/29/2014 Same as last inspection.12/9/2013 Both gates were out of water and in good condition.7/10/2013 LS and WS slopes are in good condition. Both LS and WS gates were fully submerged in water and unable to be inspected. FIELD_STRUCT_DESC: 36-inch corrugated metal drainage pipe through the levee, 9 feet below the crown. Concrete "U" headwall on both waterside (WS) and landside (LS) ends. Flap gate on the WS end. Slide gate on the LS. [Additional Reference(s): DWR Levee Log, 1993. USACE Sacramento O&M Manual 519, June 1962 (HLM 2.66)] FS Date: 6/7/2017 12:50:33 PM

Overview looking south from left levee

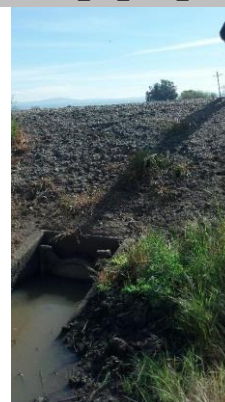
Photo 2 of 3 : UCIP_FA_2018_52120_67091.jpg

Headwall and flap gate located on WS.

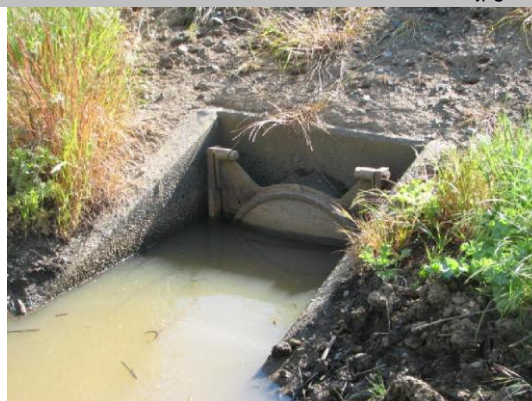
Photo 3 of 3 : UCIP_FA_2018_52120_67092.jpg

Comment Code						
Inspector Comment						
FS_ID:52120 DS_ID:16415 EP_NO: N/A Repair Type: Non-Urgent Crossing Status: Found UCIP Comments: 6/5/2017 Both gates partially submerged during site visit. Appears to be in good condition. Pipe has been selected to be internally cleaned and inspected as part of the DMP project. (DWR Sutter Yard- A Freitag)11/18/2016 LS screw gate closed but partially buried. WS flapgate was half submerged for inspection. (DWR Sutter Yard- A Freitag)4/27/2016 Both gates were underwater for inspection.7/01/2015 WS flap gate is partially held open by sediment and needs to be dug out to allow it to fully close.5/29/2014 Same as last inspection.12/9/2013 Both gates were out of water and in good condition.7/10/2013 LS and WS slopes are in good condition. Both LS and WS gates were fully submerged in water and unable to be inspected. FIELD_STRUCT_DESC: 36-inch corrugated metal drainage pipe through the levee, 9 feet below the crown. Concrete "U" headwall on both waterside (WS) and landside (LS) ends. Flap gate on the WS end. Slide gate on the LS. [Additional Reference(s): DWR Levee Log, 1993. USACE Sacramento O&M Manual 519, June 1962 (HLM 2.66)] FS Date: 6/7/2017 12:50:33 PM

WS headwall and flap gate.

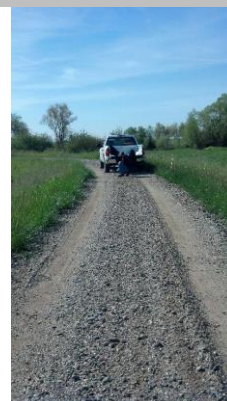
Photo 1 of 3 : UCIP_FA_2018_52121_67094.jpg

Comment Code					
Inspector Comment					
<p>FS_ID:52121 DS_ID:16405 EP_NO: N/A Repair Type: Non-Urgent Crossing Status: Found UCIP Comments: 6/5/2017 Abandoned- LS slide gate completely buried in rice field and WS wrlap gate almost fully buried. (DWR Sutter Yard- AFreitag)11/18/2016 appears abandoned. Both gates completely buried. (DWR Sutter Yard- AFreitag)4/27/2016 Crossing appears abandoned. LS screw gate still buried and WS flap gate was 95% buried.7/01/2015 Still a non functioning crossing. LS screw gate is completely buried by sediment with only part of its frame and stem visible. WS flapgate is blocked from opening by sediment and debris.5/29/2014 Same as last inspection.12/9/2013 LS slide gate is completely buried by soil and WS flap gate is blocked from opening by sediment. Crossing appears abandoned and non-function.</p> <p>7/10/2013 LS and WS slopes have been cleared by vegetation and are in good condition. WS flap gate is out of water but is blocked from opening by sediment build up. LS gate is fully submerged and not able to be inspected.4/19/2012 Non-functioning crossing. Farmer uses pipe located at LM 3.682 to drain field & not this one. Dense vegetation-need photos of cleared WS & LS slopes. This crossing was listed in the USACE Periodic Inspection report as Corp's inspect ID# USACE_CESPK_M13G_2011_p_0172 for no access to WS gate due to high water & dense vegetation.</p> <p>FIELD_STRUCT_DESC: *ABANDONED* 36-inch corrugated metal drainage pipe through the levee, 11.5 feet below the crown. Concrete "U" headwalls located on both the waterside (WS) and landside (LS) ends. Flap gate on the WS end. Slide gate on the LS end. [Additional Reference(s): DWR Levee Log, 1993. USACE Sacramento O&M Manual 519, June 1962 (HLM 3.61)]</p> <p>FS Date: 6/7/2017 12:58:12 PM</p>

Overview looking south from left levee

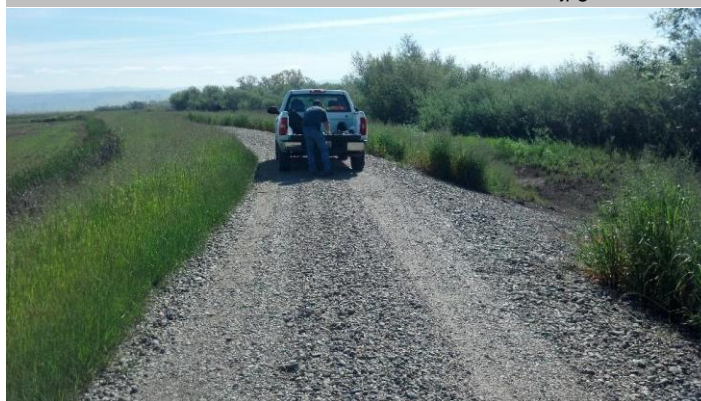
Photo 1 of 3 : UCIP_FA_2018_52122_67102.jpg

Comment Code						
Inspector Comment						
FS_ID:52122 DS_ID:16848 EP_NO: N/A Repair Type: No Action Needed Crossing Status: Found UCIP Comments: 6/5/2017 Both ends submerged but appear to be in good condition. Pipe has been selected to be internally cleaned and inspected as part of the DMP project. (DWR Sutter Yard- A/Freitag)11/18/2016 Crossing appears to be in good condition. (DWR Sutter Yard- A/Freitag)4/27/2016 Crossing appears to be in good condition. New slide gate installed on LS.7/01/2015 Both gates were still submerged in water. Levee slopes were in good condition.5/29/2014 Same as last inspection.12/9/2013 Same as last inspection.7/10/2013 LS slope has been cleared of vegetation and is in good condition. Both gates are still underwater and not able to be inspected.4/19/2012 Dense vegetation makes it difficult to evaluate the condition of the LS slope. Both gates underwater. Recommend taking photos of clear slopes and gates during fall inspection. FIELD_STRUCT_DESC: 36-inch corrugated metal drainage pipe through the levee, 9.2 feet below the crown. Concrete "U" headwalls on both the waterside (WS) and landside (LS) ends. Flap gate on the WS end. Slide gate on the LS end. [Additional Reference(s): DWR Levee Log, 1993. USACE Sacramento O&M Manual 519, June 1962 (HLM 3.67)] FS Date: 6/7/2017 1:21:24 PM

Overview looking south on left levee

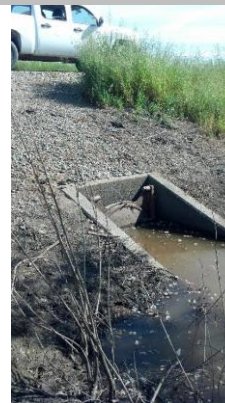
Photo 2 of 3 : UCIP_FA_2018_52122_67103.jpg

Headwall and flap gate located on WS.

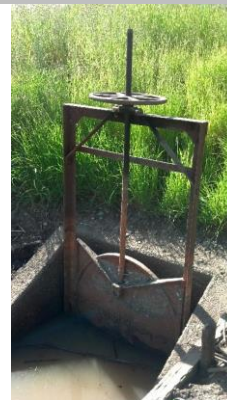
Photo 3 of 3 : UCIP_FA_2018_52122_67101.jpg

Item	DWR UCIP LMA Responsibility			39.523556 °		39.523556 °
				-121.705340 °		-121.705340 °
DWR ID	16848					
Comment Code						
Inspector Comment						
FS_ID:52122						
DS_ID:16848						
EP_NO: N/A						
Repair Type: No Action Needed						
Crossing Status: Found						
UCIP Comments: 6/5/2017 Both ends submerged but appear to be in good condition. Pipe has been selected to be internally cleaned and inspected as part of the DMP project. (DWR Sutter Yard- A Freitag)11/18/2016 Crossing appears to be in good condition. (DWR Sutter Yard- A Freitag)4/27/2016 Crossing appears to be in good condition. New slide gate installed on LS.7/01/2015 Both gates were still submerged in water. Levee slopes were in good condition.5/29/2014 Same as last inspection.12/9/2013 Same as last inspection.7/10/2013 LS slope has been cleared of vegetation and is in good condition. Both gates are still underwater and not able to be inspected.4/19/2012 Dense vegetation makes it difficult to evaluate the condition of the LS slope. Both gates underwater. Recommend taking photos of clear slopes and gates during fall inspection.

Headwall and screw gate located on LS.

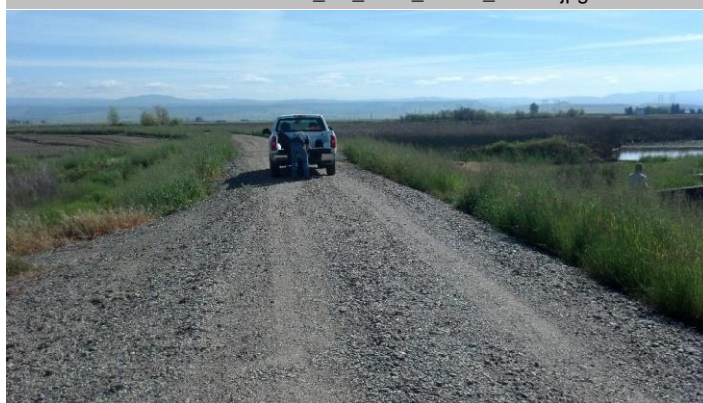
Photo 1 of 3 : UCIP_FA_2018_52123_67107.jpg

FS_ID:52123
DS_ID:16847
EP_NO: N/A
Repair Type: Non-Urgent
Crossing Status: Found
UCIP Comments: 6/5/2017 Both ends submerged but crossing appears to be in good condition. (DWR Sutter Yard- A Freitag)11/18/2016 Crossing appears to be in good condition. It appears that this crossing does not require a slide gate. (DWR Sutter Yard- A Freitag)4/27/2016 LS slide gate was still missing. Rest of crossing appears to be in good condition.7/01/2015 There appears to be a LS gate now but both pipe ends were submerged so it was hard to tell for certain.5/29/2014 Same as last inspection.12/9/2013 Pulled sticks from WS flap gate to allow it to close. Ls gate is still missing.7/10/2013 WS and LS slopes have been cleared of vegetation and are in good condition. LS gate is still missing and WS flap gate is still wedged open with sticks.4/19/2012 LS gate missing & limited inspection. Need photos of WS & LS cleared slopes. Description calls for slide gate on LS-slide gate missing. Debris scattered near LS headwall. This crossing was listed in the USACE Periodic Inspection report as Corp's Inspect ID# USACE_CESPK_M13J_2011_p_0010 for WS gate wedged open & missing LS slide gate.

Overview looking south on left levee

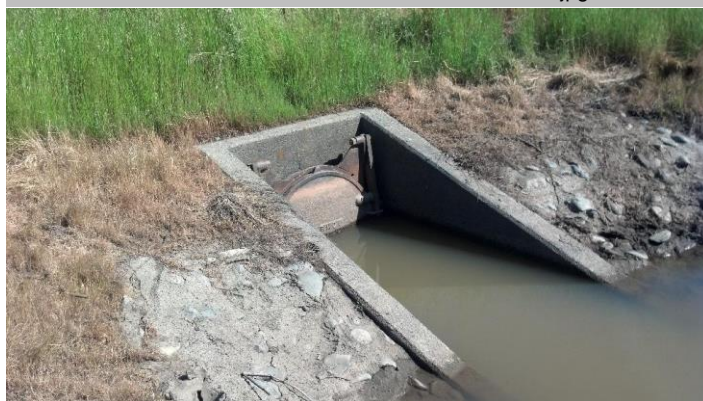
Photo 2 of 3 : UCIP_FA_2018_52123_67108.jpg

FS_ID:52123
DS_ID:16847
EP_NO: N/A
Repair Type: Non-Urgent
Crossing Status: Found
UCIP Comments: 6/5/2017 Both ends submerged but crossing appears to be in good condition. (DWR Sutter Yard- A Freitag) 11/18/2016 Crossing appears to be in good condition. It appears that this crossing does not require a slide gate. (DWR Sutter Yard- A Freitag) 4/27/2016 LS slide gate was still missing. Rest of crossing appears to be in good condition. 7/01/2015 There appears to be a LS gate now but both pipe ends were submerged so it was hard to tell for certain. 5/29/2014 Same as last inspection. 12/9/2013 Pulled sticks from WS flap gate to allow it to close. LS gate is still missing. 7/10/2013 WS and LS slopes have been cleared of vegetation and are in good condition. LS gate is still missing and WS flap gate is still wedged open with sticks. 4/19/2012 LS gate missing & limited inspection. Need photos of WS & LS cleared slopes. Description calls for slide gate on LS- slide gate missing. Debris scattered near LS headwall. This crossing was listed in the USACE Periodic Inspection report as Corp's Inspect ID# USACE_CESPK_M13J_2011_p_0010 for WS gate wedged open & missing LS slide gate.

Headwall and flap gate located on WS toe.

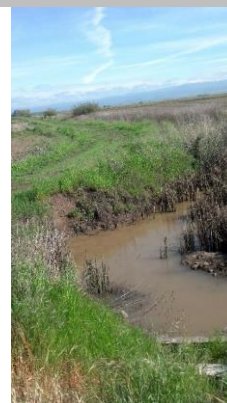
Photo 3 of 3 : UCIP_FA_2018_52123_67110.jpg

Comment Code						
Inspector Comment						
FS_ID:52123 DS_ID:16847 EP_NO: N/A Repair Type: Non-Urgent Crossing Status: Found UCIP Comments: 6/5/2017 Both ends submerged but crossing appears to be in good condition. (DWR Sutter Yard-AFreitag)11/18/2016 Crossing appears to be in good condition. It appears that this crossing does not require a slide gate. (DWR Sutter Yard- AFreitag)4/27/2016 LS slide gate was still missing. Rest of crossing appears to be in good condition.7/01/2015 There appears to be a LS gate now but both pipe ends were submerged so it was hard to tell for certain.5/29/2014 Same as last inspection.12/9/2013 Pulled sticks from WS flap gate to allow it to close. Ls gate is still missing.7/10/2013 WS and LS slopes have been cleared of vegetation and are in good condition. LS gate is still missing and WS flap gate is still wedged open with sticks.4/19/2012 LS gate missing & limited inspection. Need photos of WS & LS cleared slopes. Description calls for slide gate on LS-slide gate missing. Debris scattered near LS headwall. This crossing was listed in the USACE Periodic Inspection report as Corp's Inspect ID# USACE_CESPK_M13J_2011_p_0010 for WS gate wedged open & missing LS slide gate. FIELD_STRUCT_DESC: 36-inch corrugated metal drainage pipe through the levee, 8.8 feet below the crown. Flap gate on the waterside (WS) end. Slide gate on the landside (LS) end. Concrete "U" headwalls on both ends. [Additional Reference(s): DWR Levee Log, 1993. USACE Sacramento O&M Manual 519, June 1962 (HLM 3.85)] FS Date: 6/7/2017 1:24:40 PM

View of channel at crossing looking D/S.

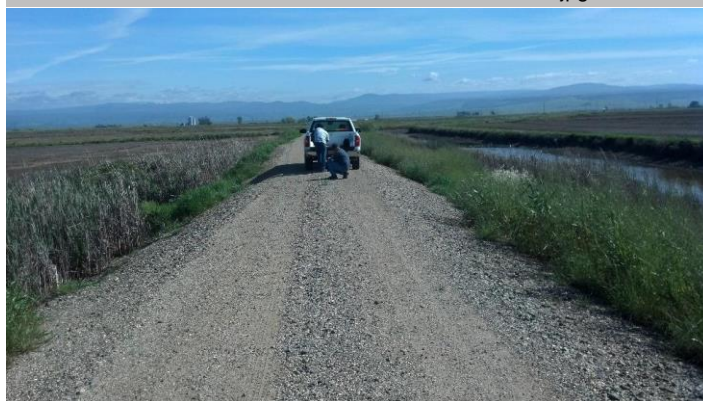
Photo 1 of 3 : UCIP_FA_2018_52124_67115.jpg

FS_ID:52124
DS_ID:16846
EP_NO: N/A
Repair Type: Non-Urgent
Crossing Status: Found
UCIP Comments: 6/5/2017 Both ends submerged during site visit. Pipe has been selected to be internally cleaned and inspected as part of the DMP project. (DWR Sutter Yard- AFreitag)11/18/2016 Both pipe ends underwater for this inspection. (DWR Sutter Yard- AFreitag)4/27/2016 Both pipe ends were underwater for inspection.7/01/2015 Both pipe ends and gates were fully submerged.5/29/2014 Same as last inspection.12/9/2013 Same as last inspection.7/10/2013 WS slope is cleared of vegetation and is in good condition. Both gates were fully submerged under water and unable to be inspected.4/19/2012 Rodent activity caused partial collapse on LS of levee in the vicinity of pipe. Limited inspection on WS slope due to dense vegetation. Limited inspection on gates due to both gates submerged under water.
FIELD_STRUCT_DESC: 36-inch corrugated metal drainage pipe through the levee, 9.3 feet below the crown. Flap gate on the waterside (WS) end. Slide gate on the landside (LS) end. Concrete "U" headwalls on both ends. Concrete sump area with flash boards to drain farmers field is located on farmer's property near drain inlet. [Additional Reference(s): DWR Levee Log, 1993. USACE Sacramento O&M Manual 519, June 1962 (HLM 4.20)]

Overview looking east on right bank of Cottonwood

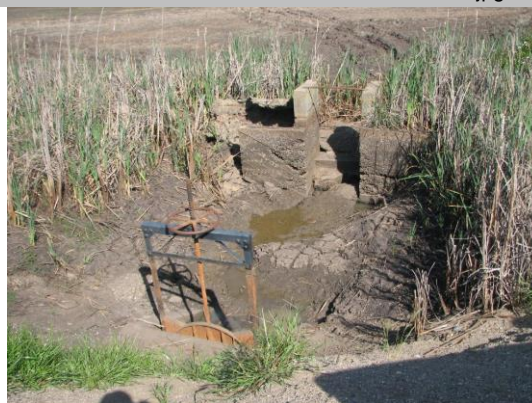
Photo 3 of 3 : UCIP_FA_2018_52124_67113.jpg

FS_ID:52124
DS_ID:16846
EP_NO: N/A
Repair Type: Non-Urgent
Crossing Status: Found
UCIP Comments: 6/5/2017 Both ends submerged during site visit. Pipe has been selected to be internally cleaned and inspected as part of the DMP project. (DWR Sutter Yard- AFreitag)11/18/2016 Both pipe ends underwater for this inspection. (DWR Sutter Yard- AFreitag)4/27/2016 Both pipe ends were underwater for inspection.7/01/2015 Both pipe ends and gates were fully submerged.5/29/2014 Same as last inspection.12/9/2013 Same as last inspection.7/10/2013 WS slope is cleared of vegetation and is in good condition. Both gates were fully submerged under water and unable to be inspected.4/19/2012 Rodent activity caused partial collapse on LS of levee in the vicinity of pipe. Limited inspection on WS slope due to dense vegetation. Limited inspection on gates due to both gates submerged under water.
FIELD_STRUCT_DESC: 36-inch corrugated metal drainage pipe through the levee, 9.3 feet below the crown. Flap gate on the waterside (WS) end. Slide gate on the landside (LS) end. Concrete "U" headwalls on both ends. Concrete sump area with flash boards to drain farmers field is located on farmer's property near drain inlet. [Additional Reference(s): DWR Levee Log, 1993. USACE Sacramento O&M Manual 519, June 1962 (HLM 4.20)]

Overview of LS screw gate and concrete sump structure.
